B-HCE Report Number 44-22003 – Pendant Properties, LLC Attachments

Photograph 21

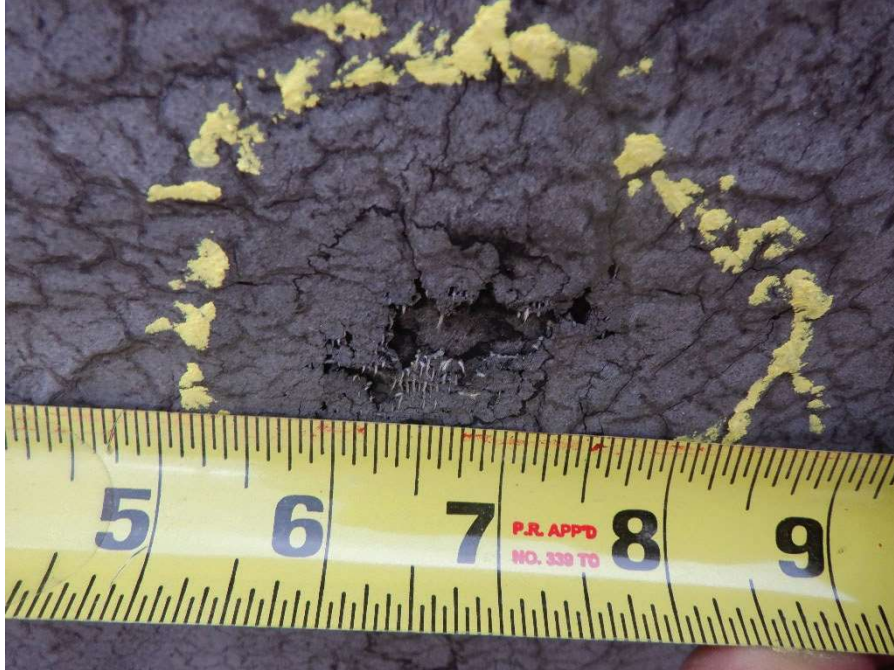
View of a spherical hail-caused impact fracture in the bitumen and reinforcement mat on the parapet wall. Note the dark bitumen.

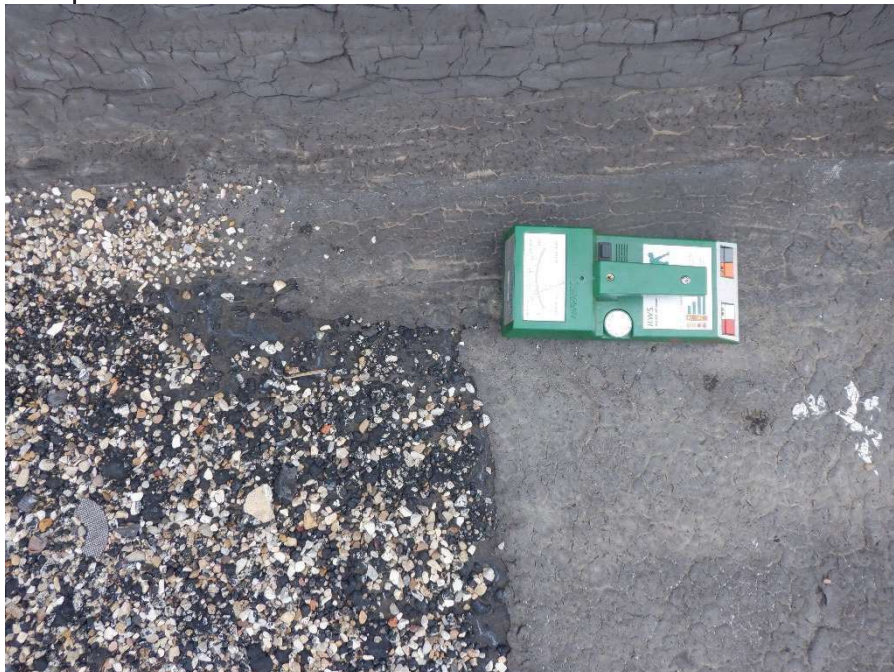
B-HCE Report Number 44-22003 – Pendant Properties, LLC Attachments

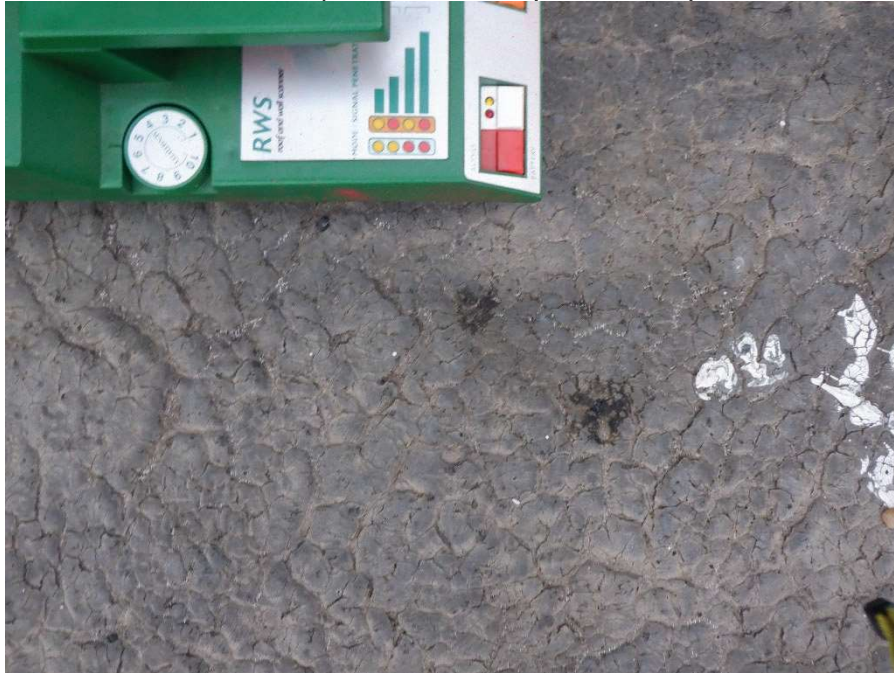
View of the dark bitumen exposure at the spherical impact marks.

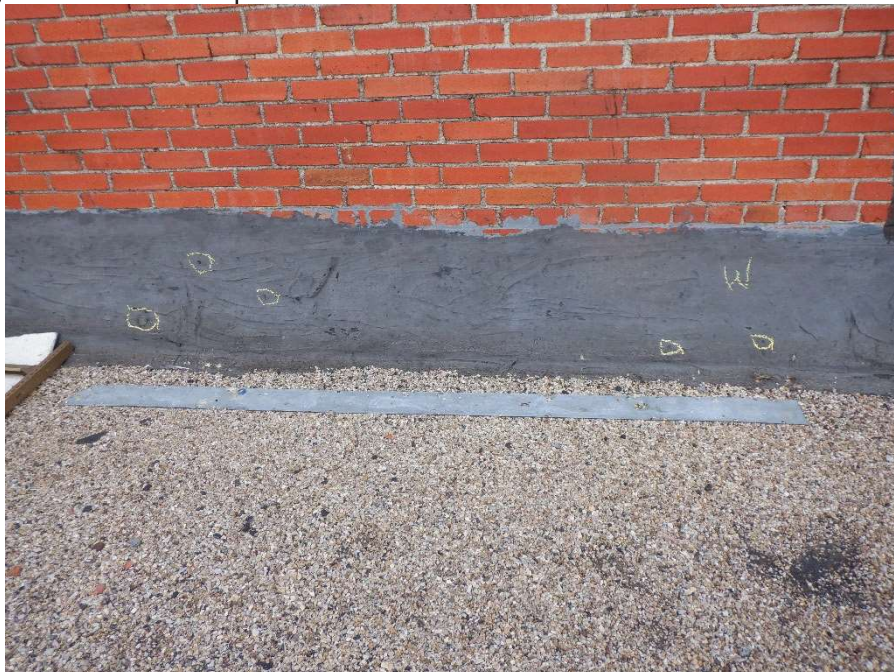
B-HCE Report Number 44-22003 – Pendant Properties, LLC Attachments

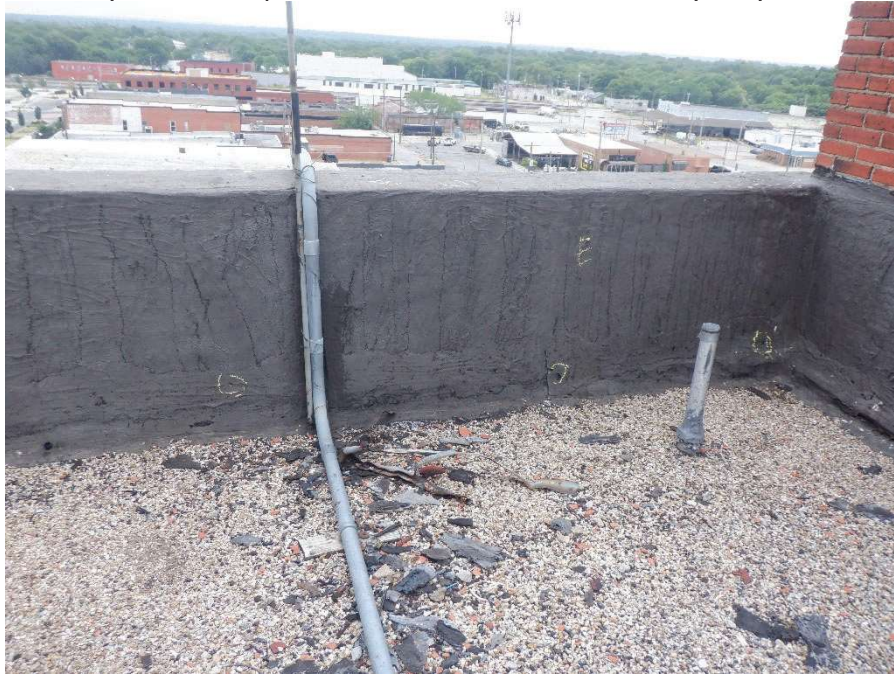
View of the spherical impact fractures in the east-side parapet.

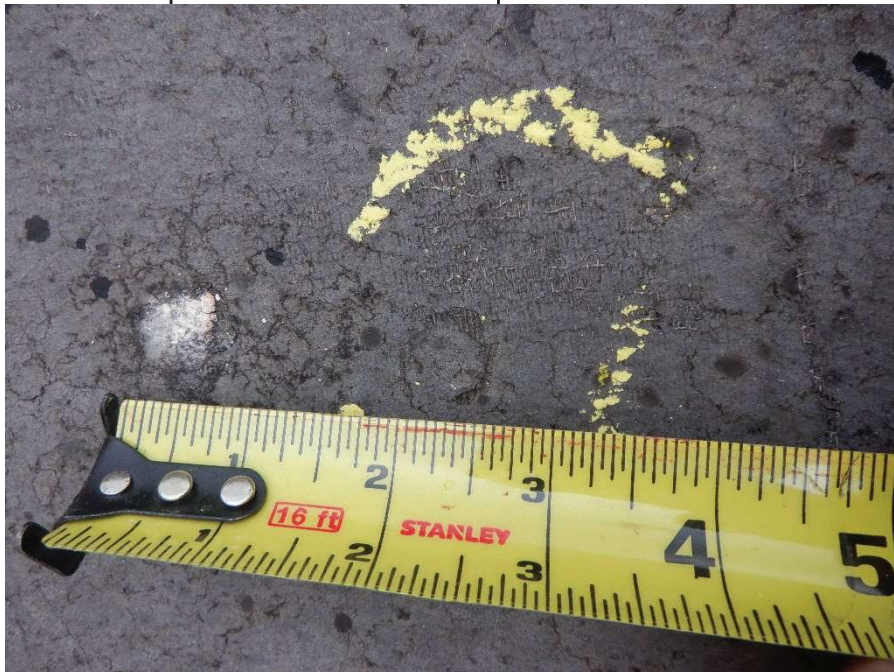
B-HCE Report Number 44-22003 – Pendant Properties, LLC Attachments

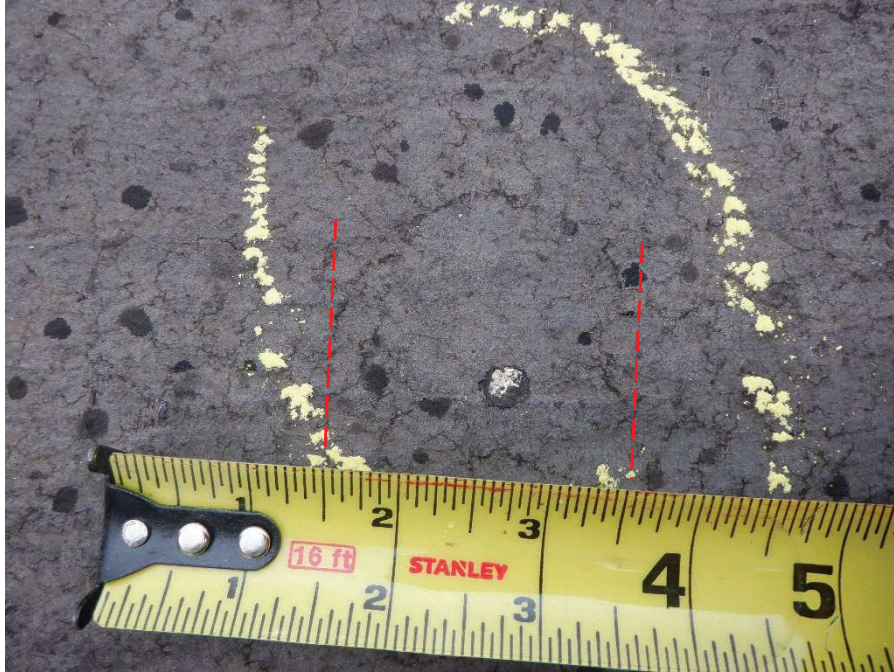
View of a spherical hail-caused fracture in the bitumen approximately 2.0 inches in diameter.

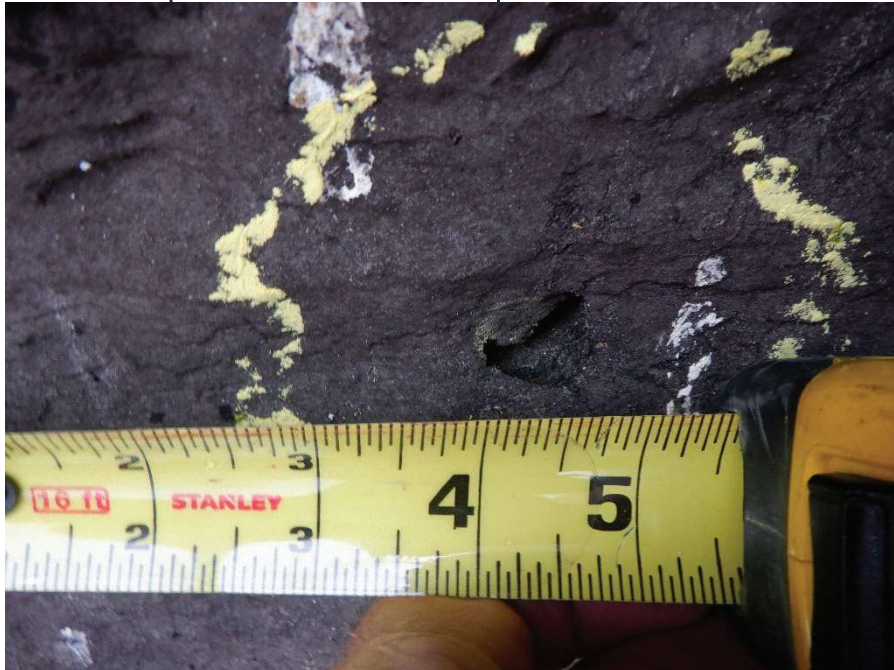
B-HCE Report Number 44-22003 – Pendant Properties, LLC Attachments

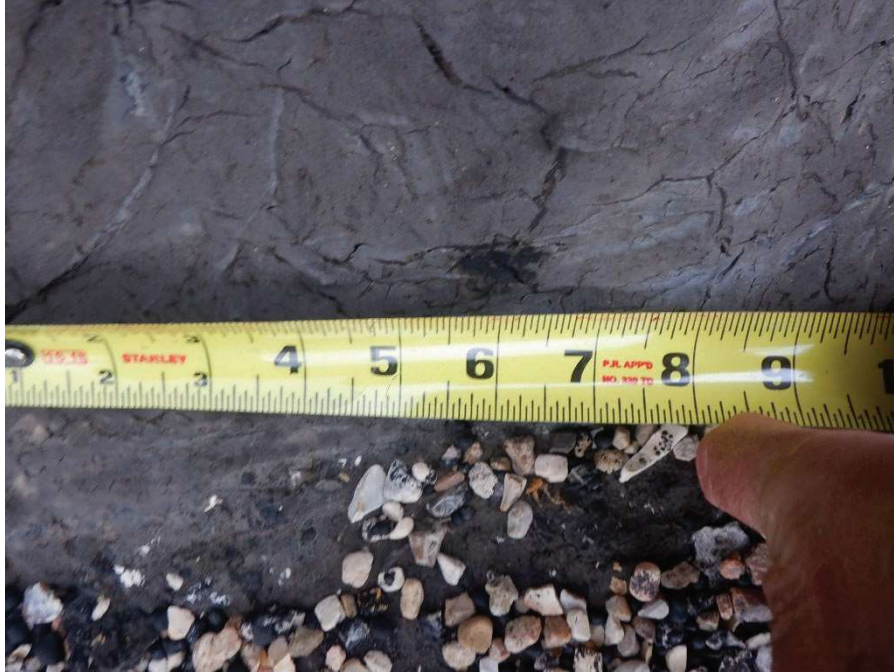
Close view of a spherical hail-caused impact fracture in the bitumen with dark bitumen exposure.

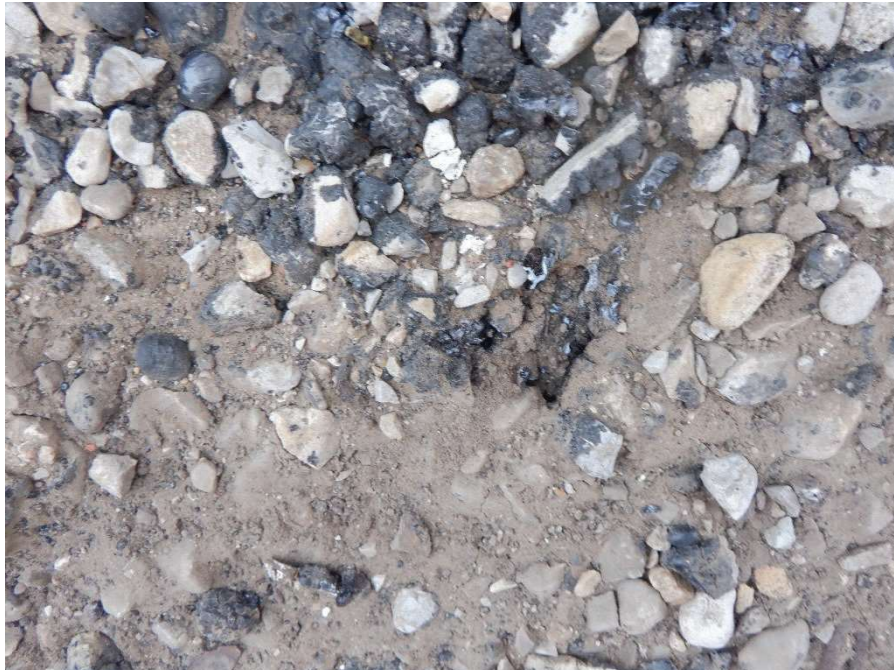
B-HCE Report Number 44-22003 – Pendant Properties, LLC Attachments

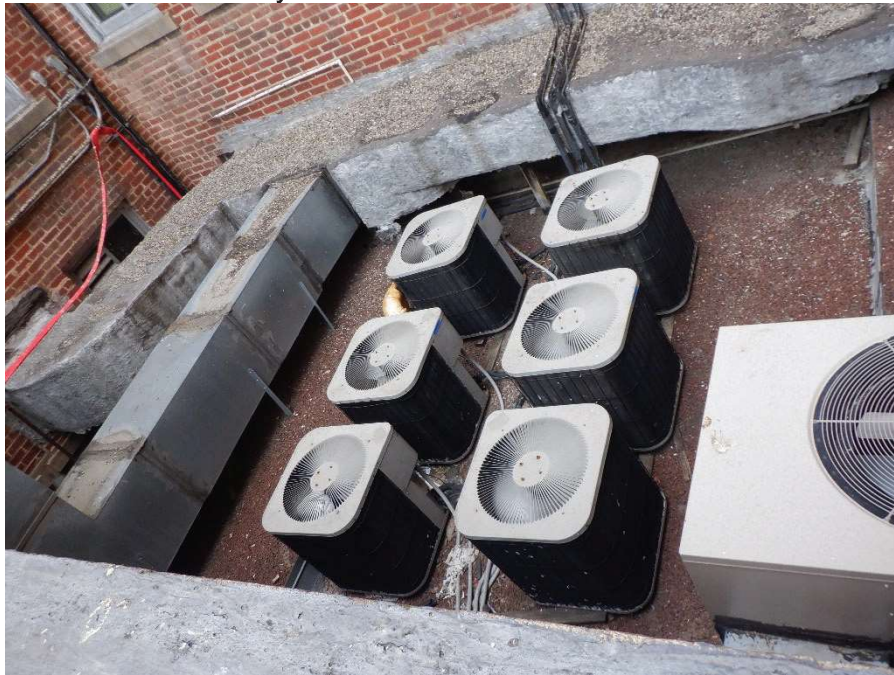
View of the lower 1st story GB BUR.

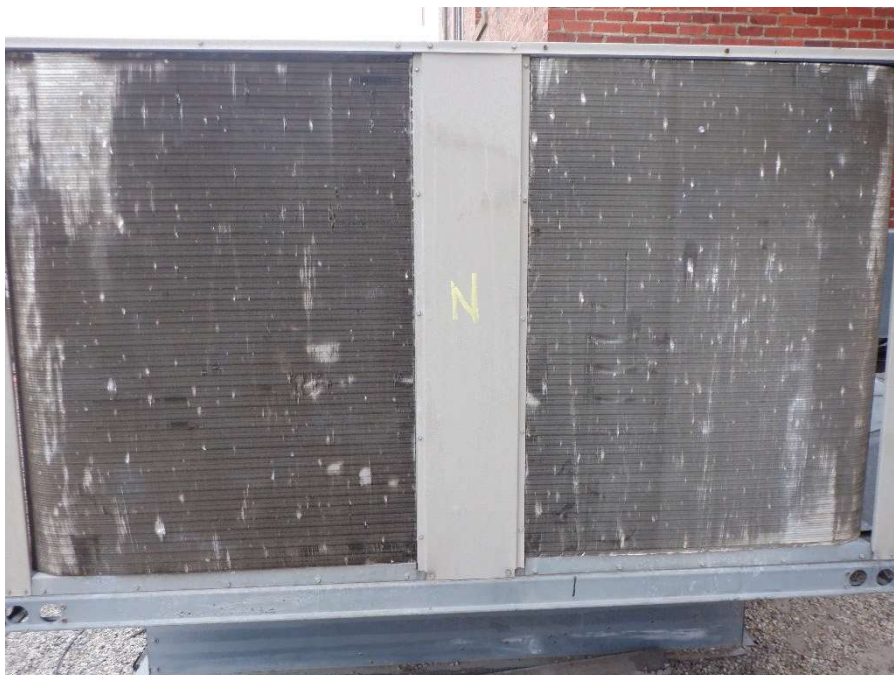
**B-HCE Report Number 44-22003 – Pendant Properties, LLC
Attachments**

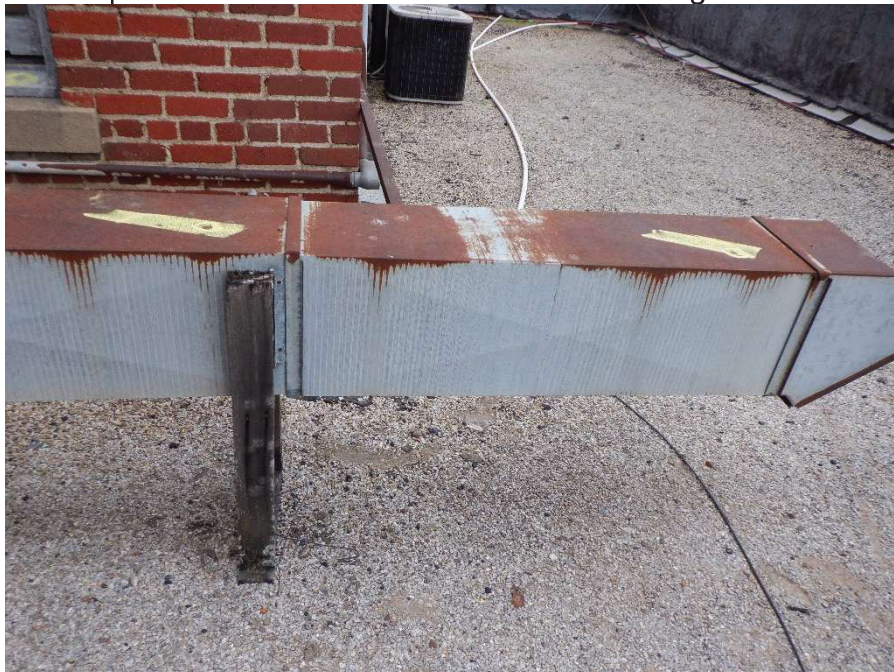
B-HCE Report Number 44-22003 – Pendant Properties, LLC Attachments

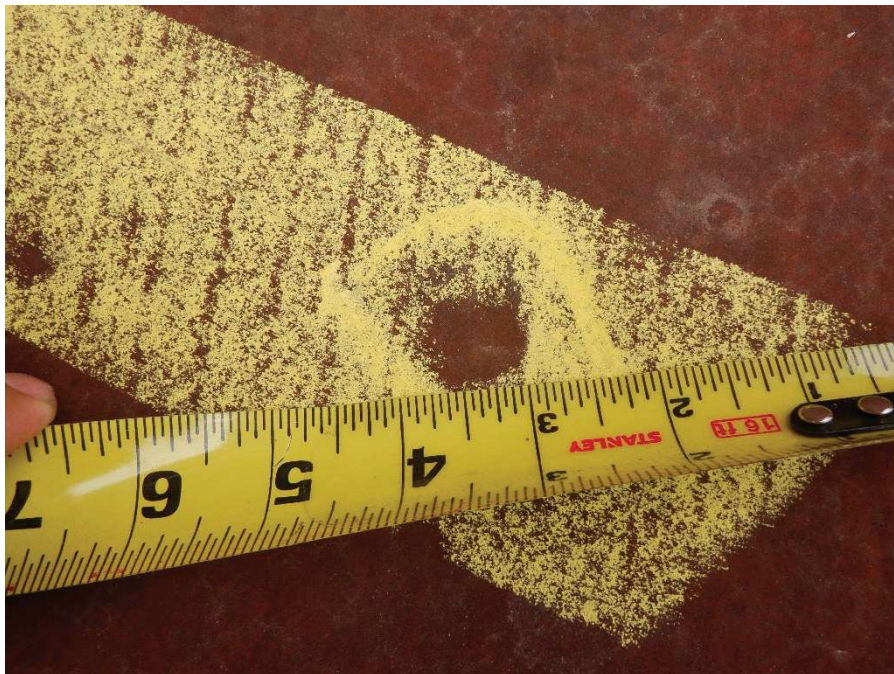
View of a spherical hail-caused indentation approximately 0.8 inches in diameter.

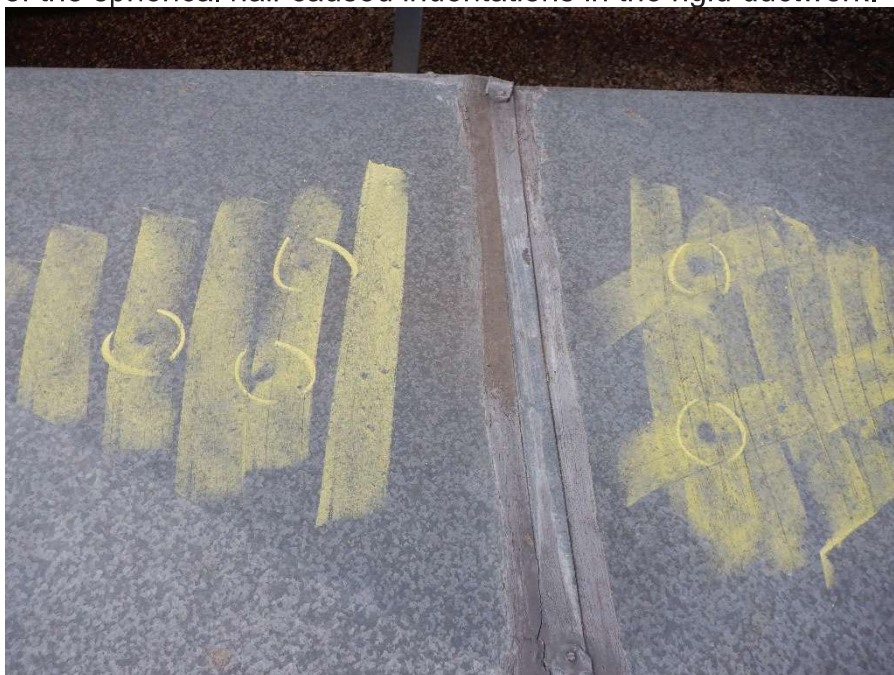
View of the spherical hail-caused indentations in the rigid ductwork.
